Manhole Inspection Summary

Manhole # S13CC1014MH

Insp Date: **2/5/09 2:41 PM**

Location Address: **3935 WABASH AVE**

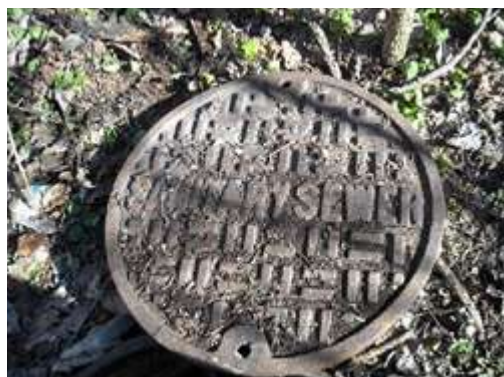
Defect 6

LID IS SOMEWHAT WORN AND RUSTED

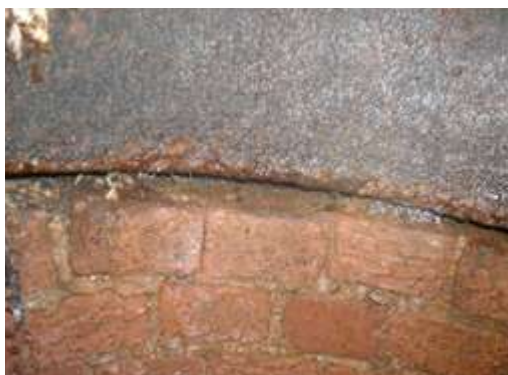
Defect 4

Condition: ☐ Sound ☐ Cracked ☒ Root Intrusion ☒ Loose Brick ☐ Deteriorated

MISSING BRICKS BELOW FRAME - 1" GAP TO CHIMNEY

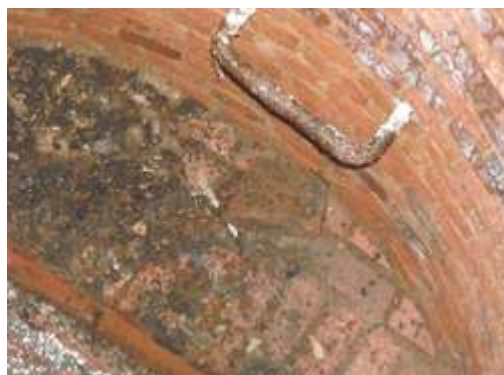
Defect 3

Steps Count: **4** Missing: **0** ☒ Corroded

DEBRIS - A BRICK - ON BENCH BELOW A CORRODED STEP

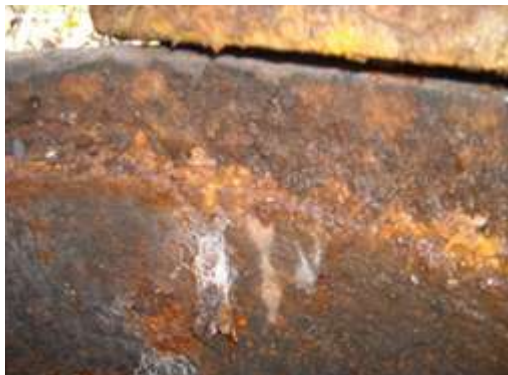
Defect 2

ROOT INTRUSION BELOW FRAME

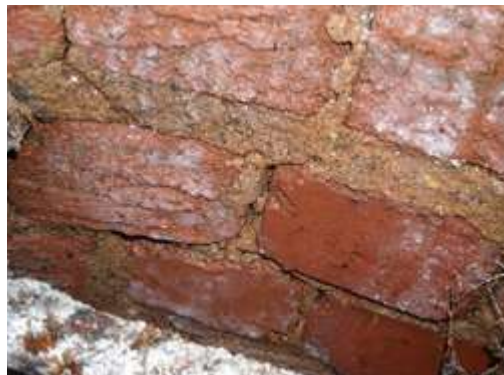
Defect 5

Infiltration: ☐ None ☐ Joint ☐ Cracks ☒ Mortar ☐ Roots ☐ Wall

MISSING MORTAR IN CORBEL WALL

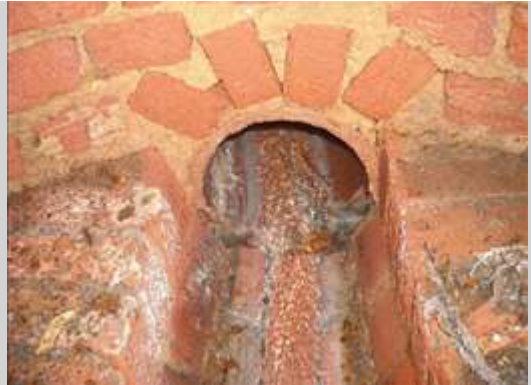
12 O'Clock Outflow

10 in. Circular Gravity Sewer
Pipe Out @ 12 O'Clock

Pipe Height: **9.6** (in.) Rod and Bar (Angled)
Pipe Material: **Clay** ☐ Pipe Lined
Invert Depth: **8.37** (ft.) Flow Characteristics: **Slow**
Deposits: ☒ None ☐ Mud ☐ Sludge ☐ Debris ☐ Grease
Silt Depth: (in.) Deposits Extent:
Infiltration: **None** Pipe Seal Cond: **Sound**

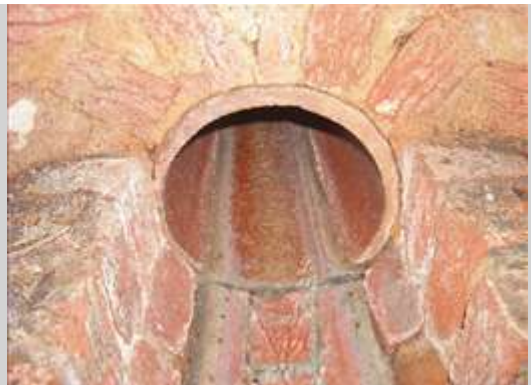
6 O'Clock Inflow

10 in. Circular Gravity Sewer
Pipe In @ 6 O'Clock

Pipe Height: **9.6** (in.) Rod and Bar (Angled)
Pipe Material: **Clay** ☐ Pipe Lined
Invert Depth: **8.05** (ft.) Flow Characteristics: **Slow**
Deposits: ☒ None ☐ Mud ☐ Sludge ☐ Debris ☐ Grease
Silt Depth: (in.) Deposits Extent:
Infiltration: **None** Pipe Seal Cond: **Sound**
